ELLIS ISLAND

ELLIS ISLAND
STATUE OF LIBERTY NATIONAL MONUMENT

EXISTING CONDITION SURVEY
UNITS 2, 3 AND 4

Volume 4
Appendix A
Part One

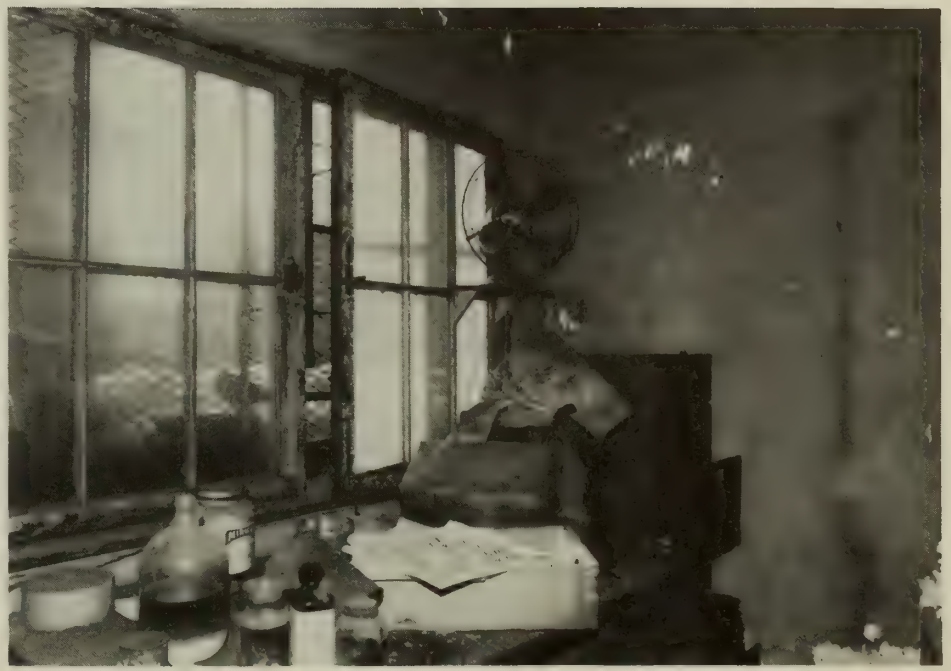
PHOTOGRAPHS: ① View Southwest ② View South east ROOM NO. 101A

FINISHES:	CONDITION:	DATE:	NOTES:
FLOOR:	[ ] Tile/Concrete [X] Resilient rolled [ ] Wood [ ] Other:	[ ] Good [ ] Fair [X] Poor [ ] Destroyed	[ ] 1911-1923 [ ] 1924-1933 [X] 1934-present [ ] In question	
BASE:	[X] Tile/Concrete [ ] Resilient [ ] Wood [ ] Other:	[ ] Good [X] Fair [ ] Poor [ ] Destroyed	[ ] 1911-1923 [ ] 1924-1933 [X] 1934-present [ ] In question	
WALLS:	[X] Plaster [ ] Partitions [ ] Tile Wainscot [ ] Other:	[ ] Good [X] Fair [ ] Poor [ ] Destroyed	[ ] 1911-1923 [ ] 1924-1933 [X] 1934-present [ ] In question	
CEILING:	[X] Plaster [ ] Acoustic panels [ ] Cove [ ] Other	[ ] Good [X] Fair [ ] Poor [ ] Destroyed	[ ] 1911-1923 [ ] 1924-1933 [X] 1934-present [ ] In question	
DOORS/ OPENINGS:	[X] ~~Wood~~/Glass Panelled [ ] Wood Veneer [ ] Galvanized Metal [X] Other: screen door	[ ] Good [X] Fair [ ] Poor [ ] Destroyed	[ ] 1911-1923 [ ] 1924-1933 [X] 1934-present [ ] In question	Metal/glass panelled: 6 lights. 1 pane destroyed. Window into 102E, casement.

LIGHTING:	[ ] Incandescent/Type A [ ] Incandescent/Type B [ ] CML/Sconce [X] Other:	[ ] Intact [ ] Destroyed [ ] Intact [ ] Destroyed [ ] Intact [ ] Destroyed [ ] Intact [X] Destroyed	[ ] 1911-1923 [ ] 1924-1933 [X] 1934-present [ ] In question	chain hanging from ceiling, lamp missing.
HEATING/ VENTILATION PLUMBING:	[X] Radiators [X] Vents/Fans [X] Sink/Toilet/Urinal [ ] Other:	[1] Intact [ ] Destroyed [1] Intact [ ] Destroyed [1] Intact [ ] Destroyed [ ] Intact [ ] Destroyed	[ ] 1911-1923 [ ] 1924-1933 [X] 1934-present [ ] In question	1 Rotary fan on shelf. 1 Wall mounted sectional radiator. 1 Wall mounted sink.
MISCELLANEOUS:		[ ] Good [ ] Fair [ ] Poor [ ] Destroyed	[ ] 1911-1923 [ ] 1924-1933 [X] 1934-present [ ] In question	Fire instructions for "whistle warning" on glass plaque on N. wall, typ. Shelf + fuse box on N. wall. Shelf over sink., ghost of mirror.
SUMMARY:		[ ] Good [X] Fair [ ] Poor [ ] Destroyed	[ ] 1911-1923 [ ] 1924-1933 [X] 1934-present [ ] In question	**ARCHITECTURAL SIGNIFICANCE:** [ ] Most [ ] Some [X] Minor [ ] Negligible

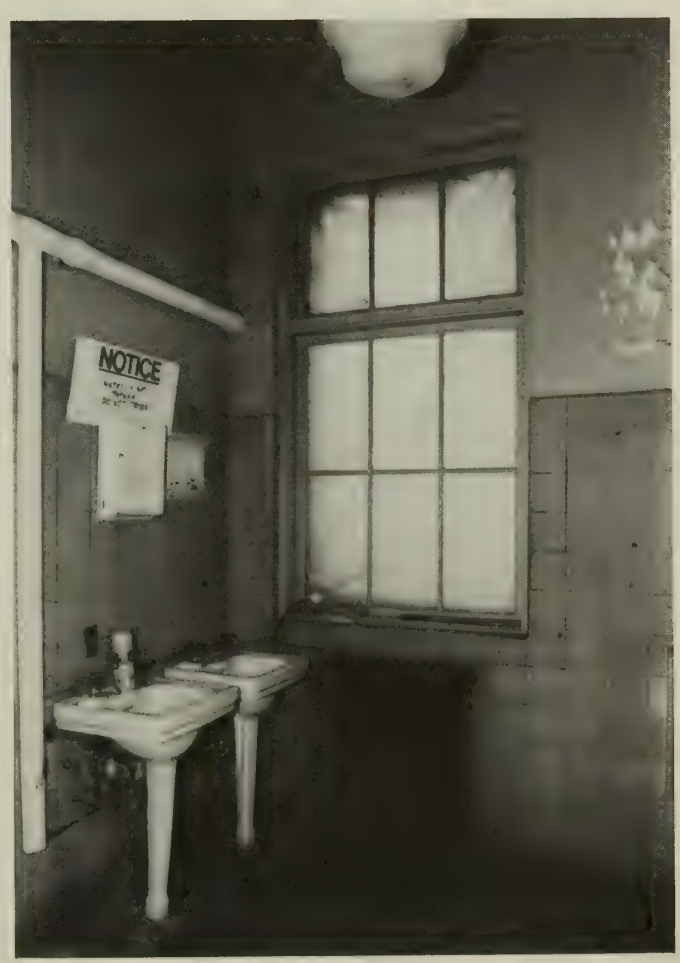
PHOTOGRAPHS: ① View southeast ② View northwest ROOM NO. 105

HEATING/ VENTILATION PLUMBING:	X Radiators X Vents/Fans X Sink/Toilet/Urinal Other:	2 Intact Destroyed 2 Intact Destroyed X Intact Destroyed Intact Destroyed	1911-1923 1924-1933 X 1934-present In question	2 new heaters. 2 central pedestal sinks. 1 slop sink in closet. 2 toilets, 2 Urinals (floor type).
MISCELLANEOUS:		X Good Fair Poor Destroyed	1911-1923 1924-1933 X 1934-present In question	Door to closet: "Danger high Voltage." "MEN" stenciled in black w/ gold trim on plaque on door.
SUMMARY:		X Good Fair Poor Destroyed	1911-1923 1924-1933 X 1934-present In question	**ARCHITECTURAL SIGNIFICANCE:** Most / Some / X Minor / Negligible

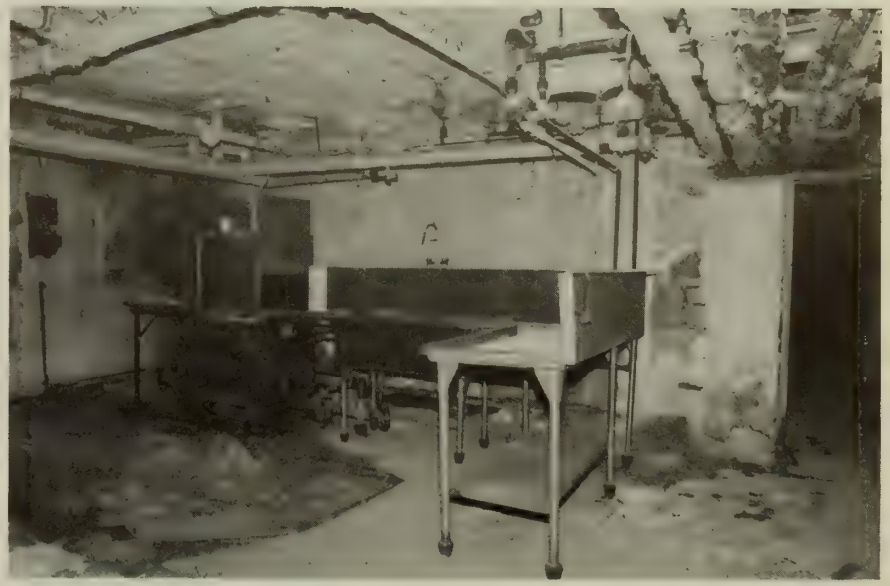
PHOTOGRAPHS: (12) 502, View Southeast. (13) Elevator. ROOM NO. Basement

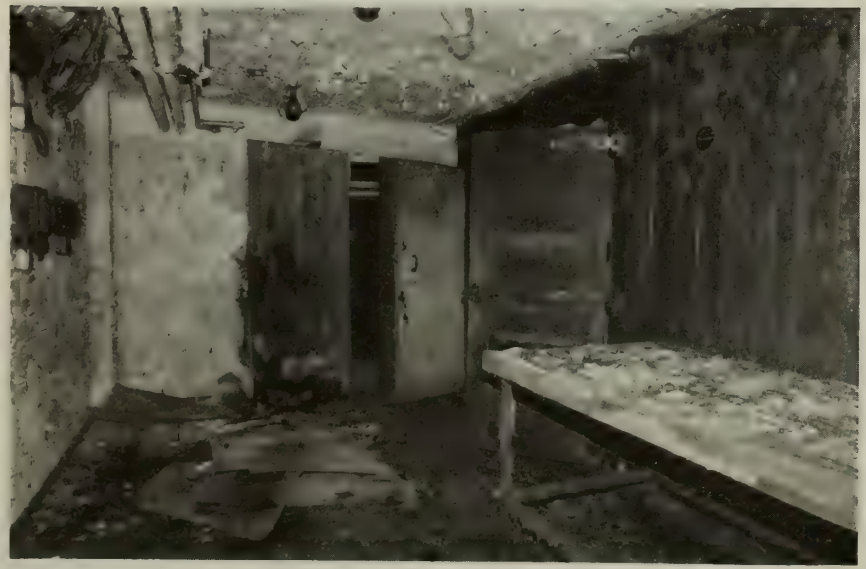
PHOTOGRAPHS: (14) B02, View Southwest (15) B07, View North ROOM NO. Basement

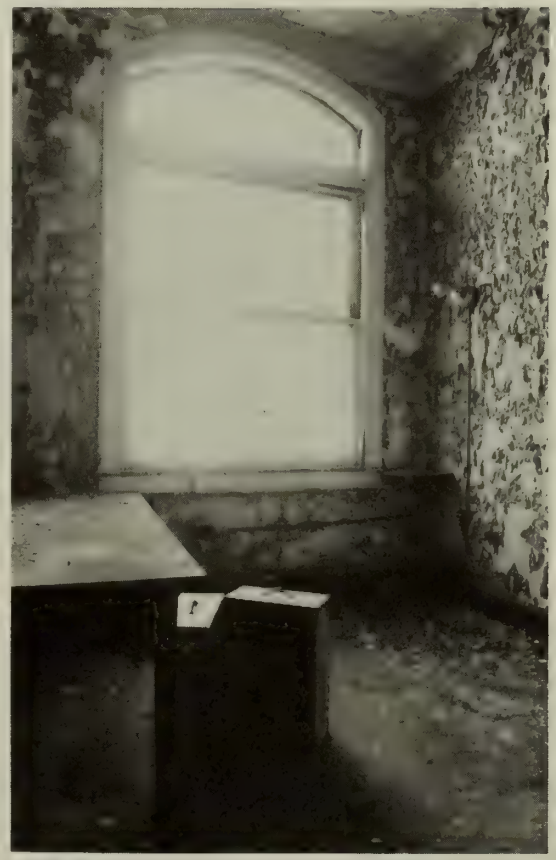
PHOTOGRAPHS: (1) View North (2) View South ROOM NO. 101

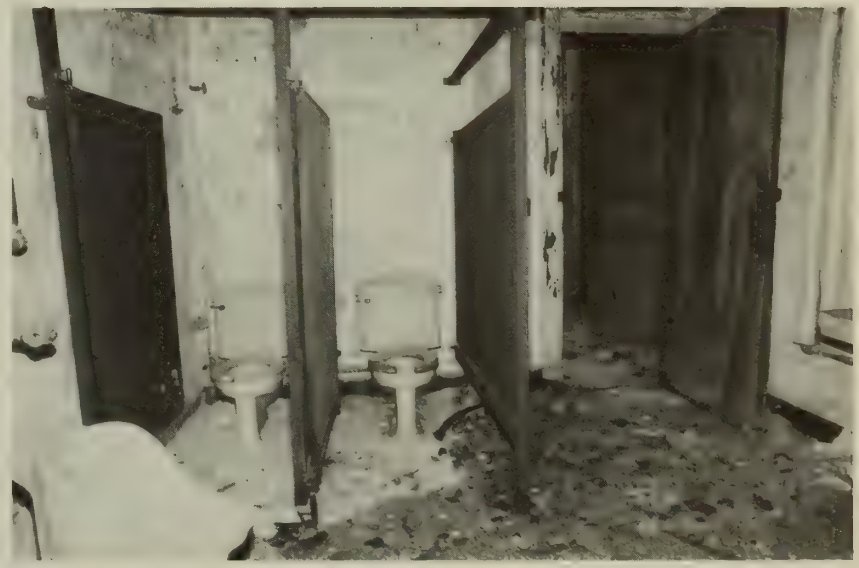
PHOTOGRAPHS: (3) View Northwest ROOM NO. 104

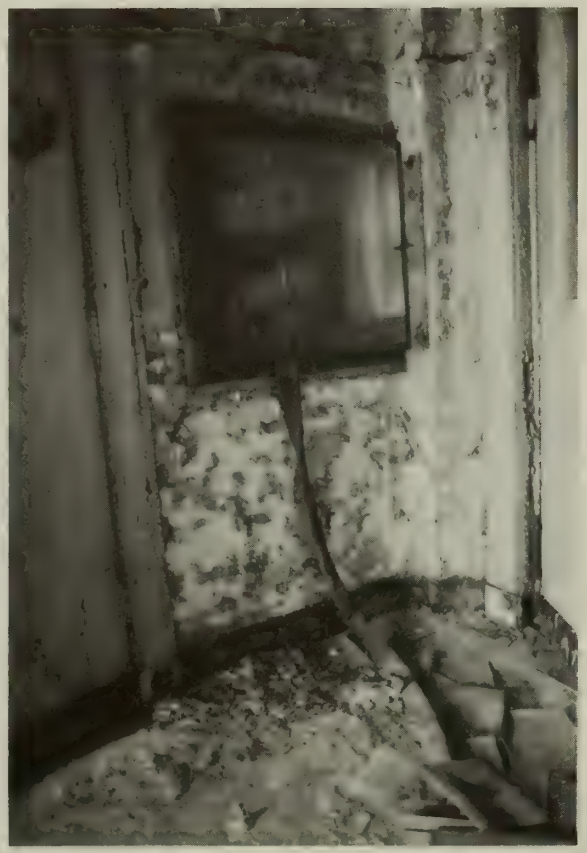
ROOM NO. H106

PHOTOGRAPHS: (1) Fire-hose box.

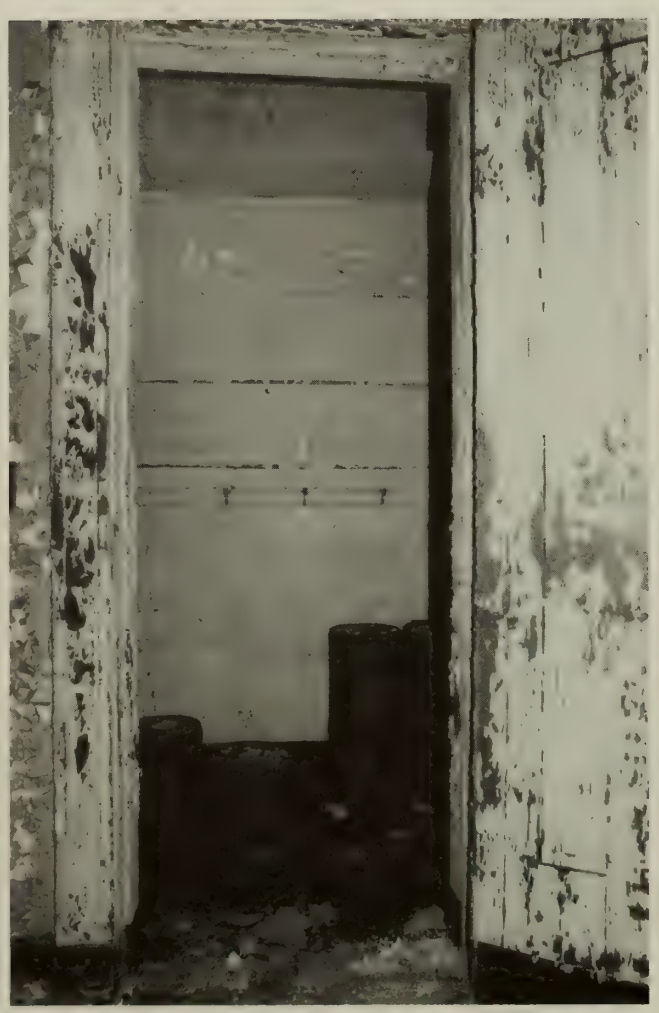
ROOM NO. H106B

PHOTOGRAPHS: (1) View South

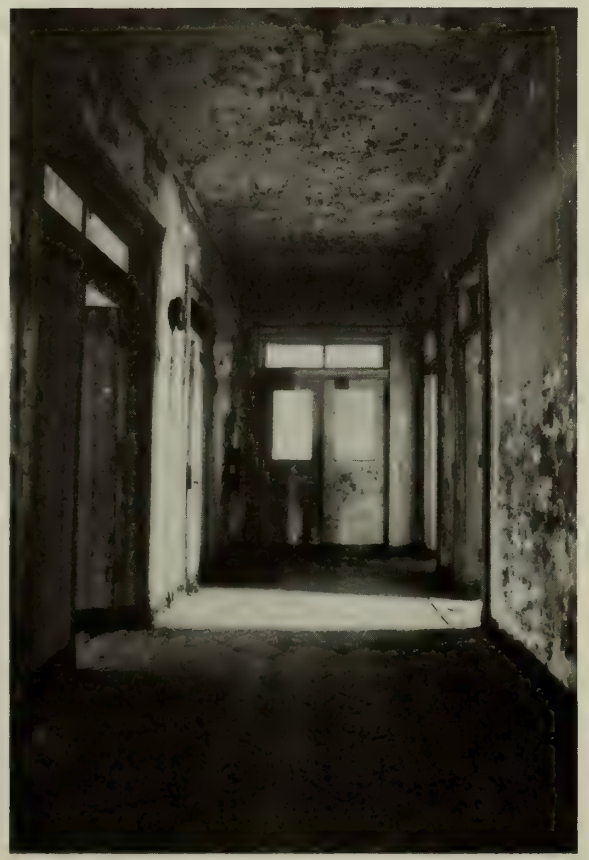
ROOM NO. H205

PHOTOGRAPHS: (1) View East

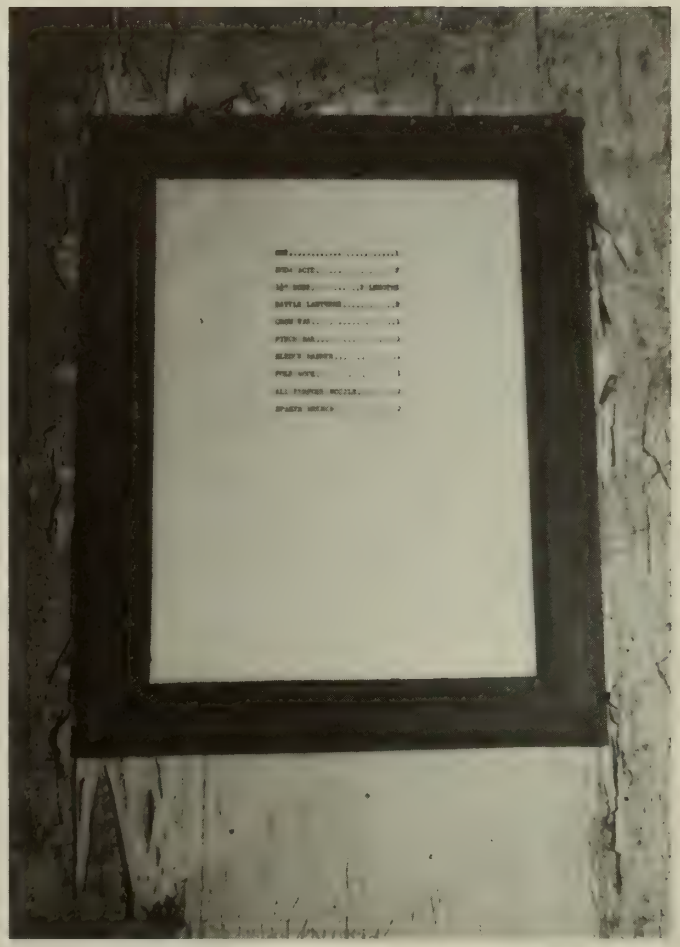
ROOM NO. H205B

PHOTOGRAPHS: (1) Inventory plaque

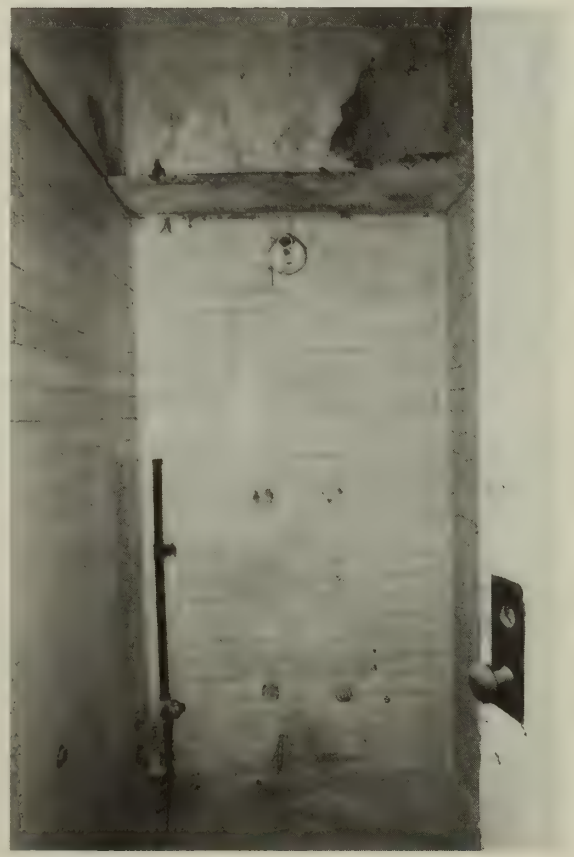
ROOM NO. I203

PHOTOGRAPHS: (1) View South

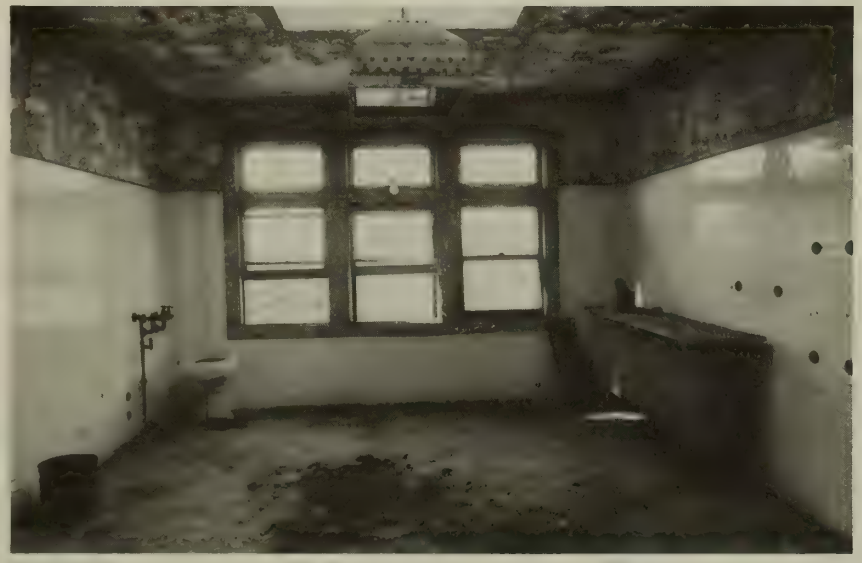
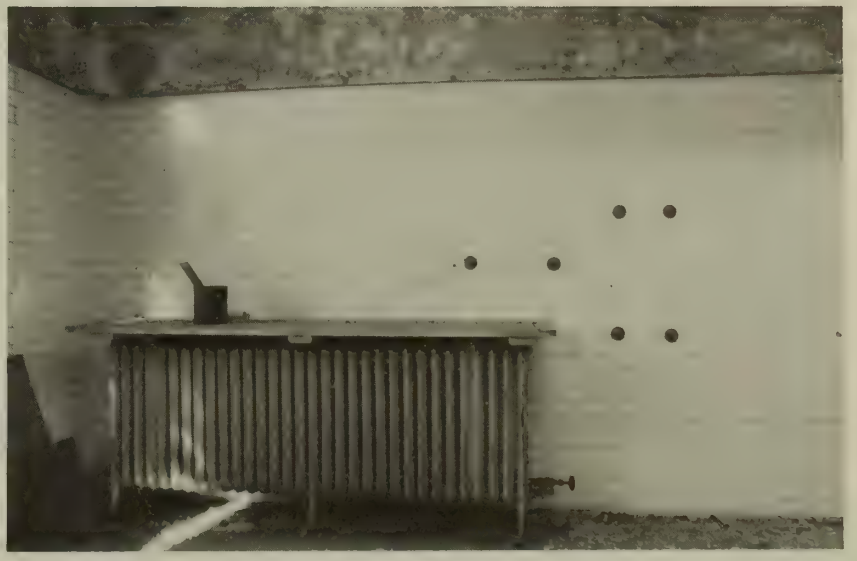
PHOTOGRAPHS: ① View North ② View South ③ View Southeast ④ View West ROOM NO. 306

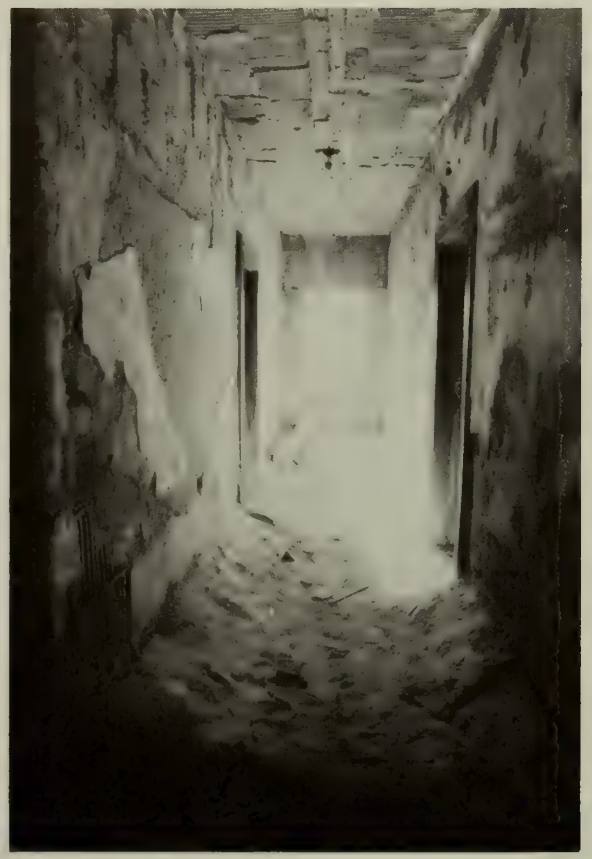
ROOM NO. H304

PHOTOGRAPHS: ① View South

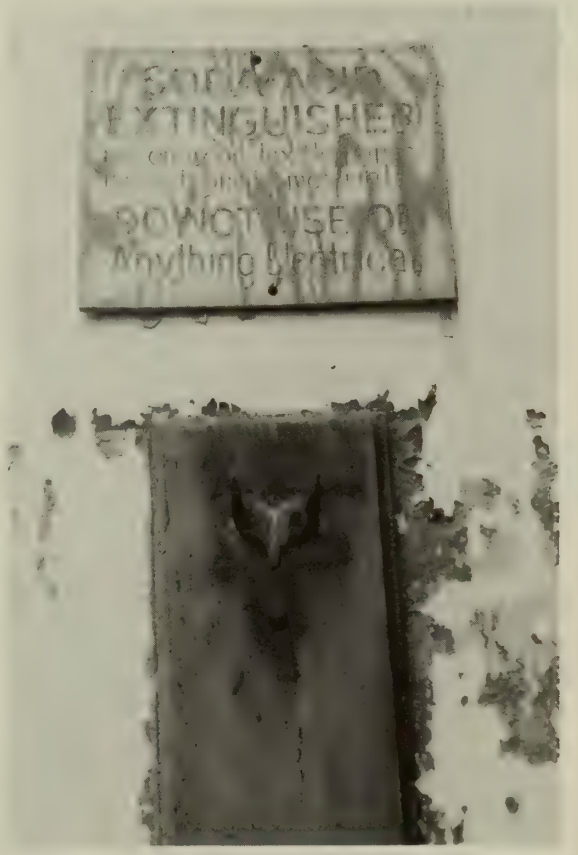
PHOTOGRAPHS: ① Fire-hose mount ② Fire extinguisher mount ROOM NO. H305
